U.S. Department of Energy
Idaho Operations Office

2005 Annual Operations Report for INTEC Operable Unit 3-13, Group 1, Tank Farm Interim Action

July 2006

Idaho Cleanup Project

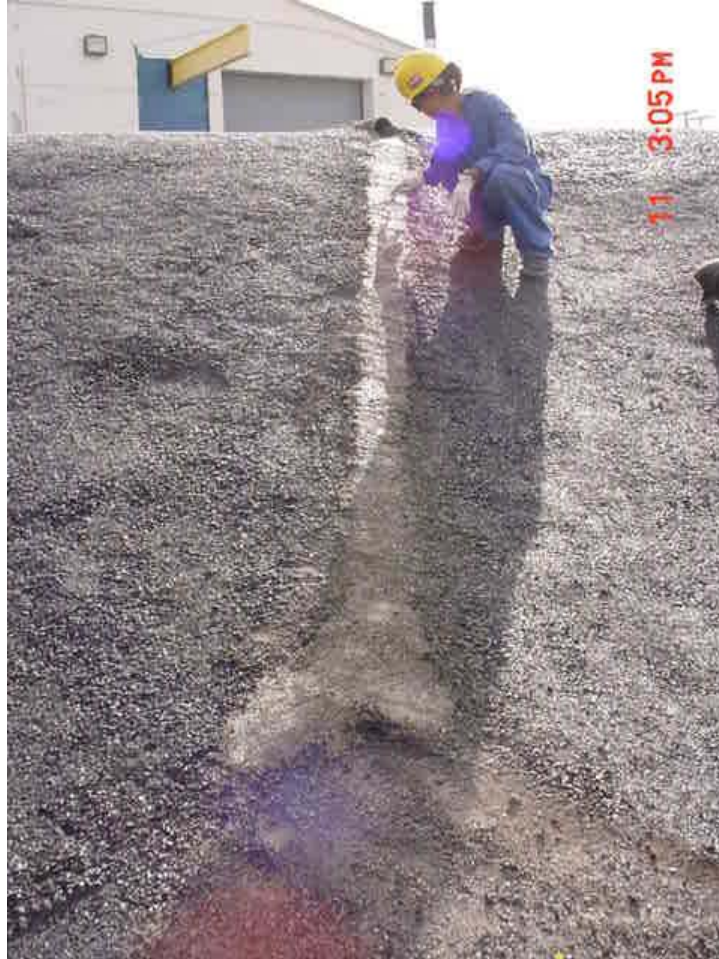
Figure B-3. Lower part of drain line over Site CPP-79 removed and depression filled in with concrete.

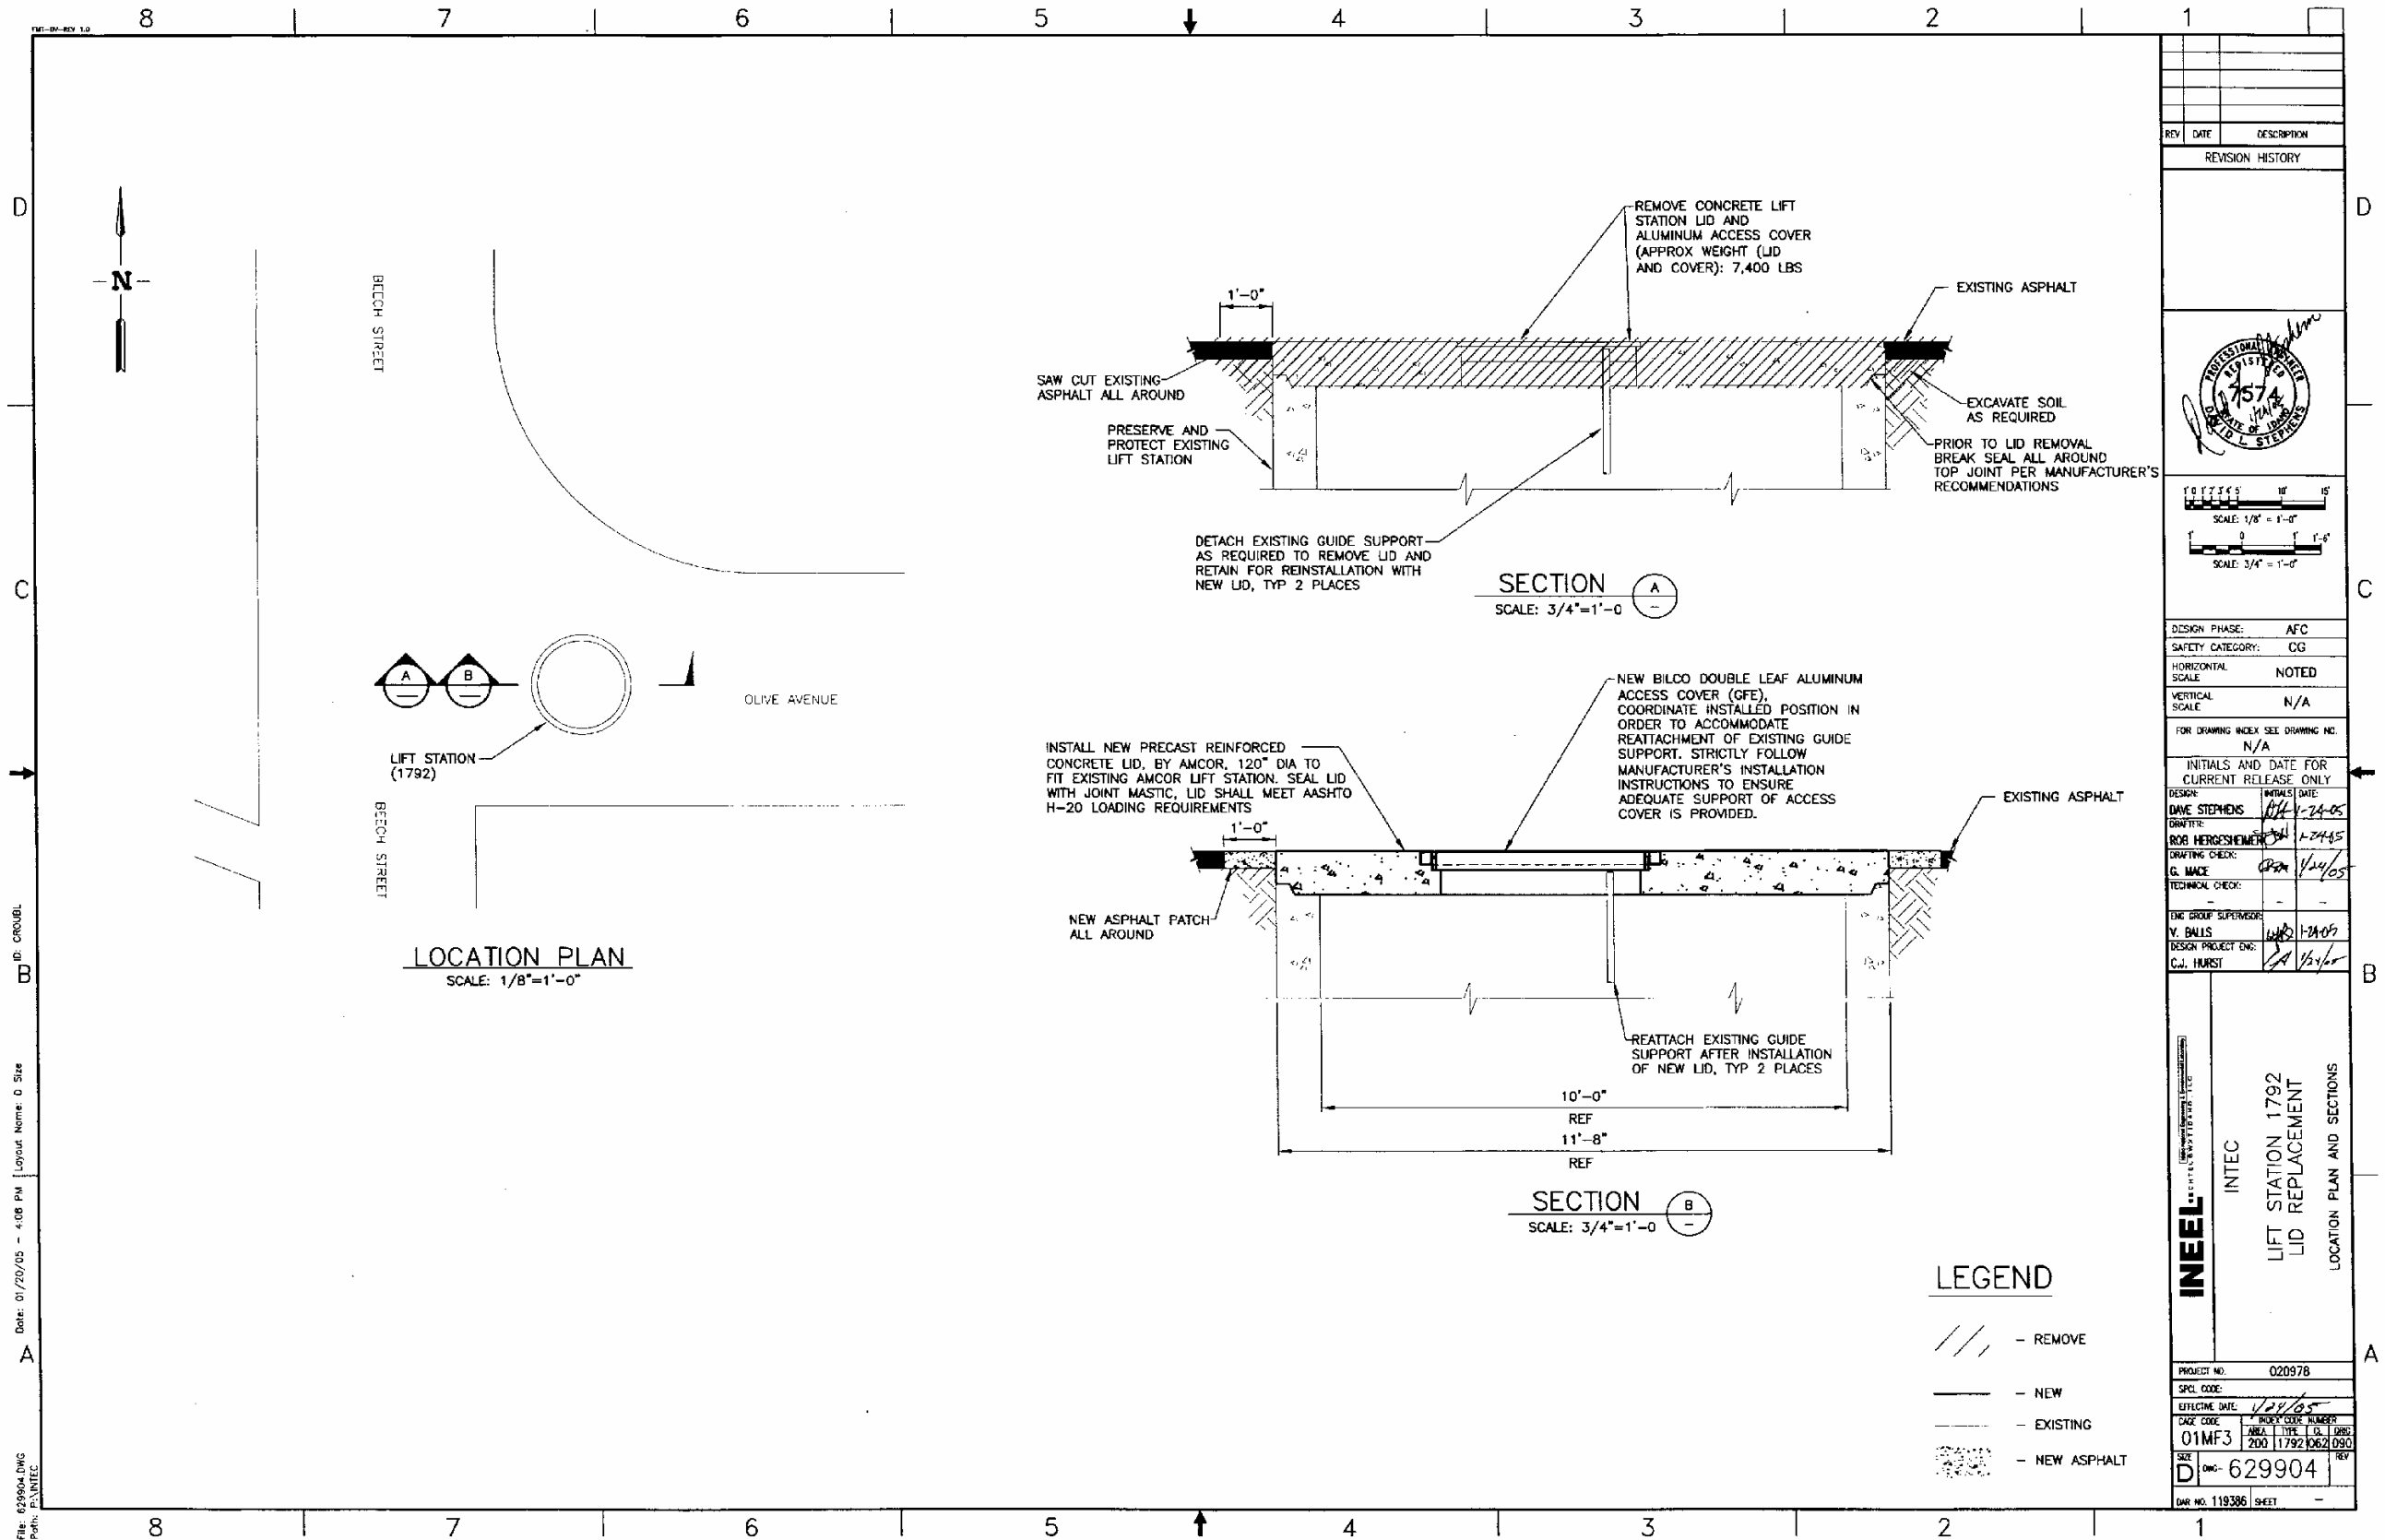
Lift Station CPP-1792 Lid Replacement Drawing

The lift station is located in the intersection of Olive Avenue and Beech Street and is identified on Figure 2-2 as CPP-1792. The station is a 10-ft-diameter by 15.8-ft-deep concrete sump covered with a pair of metal hatch doors. Major components include two 5-hp submersible sewage pumps, a forced main from the sump to the ditch discharge point, and the system controls. The system was inspected routinely as part of completing a Utilities Outside Equipment Checks (Form INTEC-6998) and quarterly as part of the TFIA routine inspections. Quarterly inspections were performed on the dates listed in Table 4-1. Inspections entailed checking for high-water-level alarms, observing water level in the sump, and visually inspecting system components. During the year only one maintenance item was reported. On January 28, 2004, it was noted on the inspection form that the lift station hatch doors had been damaged (broken weld and bent surface corners) due to excessive loads on the doors. The hatch doors were barricaded off, using traffic stanchions and rope, to prevent further damage by vehicle traffic.

As stated in the FY-04 annual report, the initial plan was to add metal bracing beneath the hatch door frame and bolt it to the concrete vault section. But, upon further inspection by the project's structural engineer and original design engineer, the decision was made to replace the lift station hatch doors and concrete lid. A precast reinforced concrete lid was fabricated that incorporated a new double-leaf aluminum access cover and was designed to meet American Association of State Highway and Transportation Officials H-20 loading requirements to prevent a reoccurrence. In August 2005, the old hatch cover was replaced by the new precast cover (see drawing in Appendix C for replacement details). The replacement activities required the removal of the asphalt from around the old lid, and this asphalt was not replaced due to delays in the INTEC facility annual asphalt maintenance program. This area was filled in with soil and compacted. The compacted soil is scheduled to be replaced with asphalt during the 2006 INTEC asphalt maintenance activity. This did not impact the operability of the system, which functioned normally during 2005.
